Research Article

Recent hydraulic bridge failures in China: review and discussion

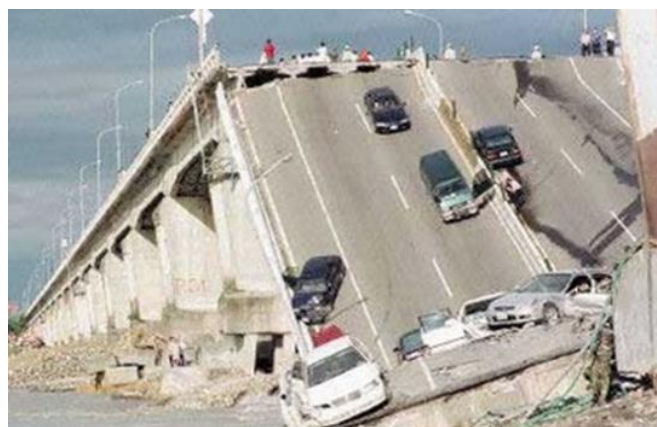
Taiwan Gaoping Bridge was a continuous beam bridge and about 1990 meters long. On August 27, 2000, severe tropical storm Bilis destroyed some piers of Gaoping Bridge. The bridge deck collapsed about 100 meters, a total of 17 vehicles collided on the road, and 22 people were seriously injured, as shown in Figure 1 (Sina, 2000).

Figure 1. Collapse of Gaoping Bridge.

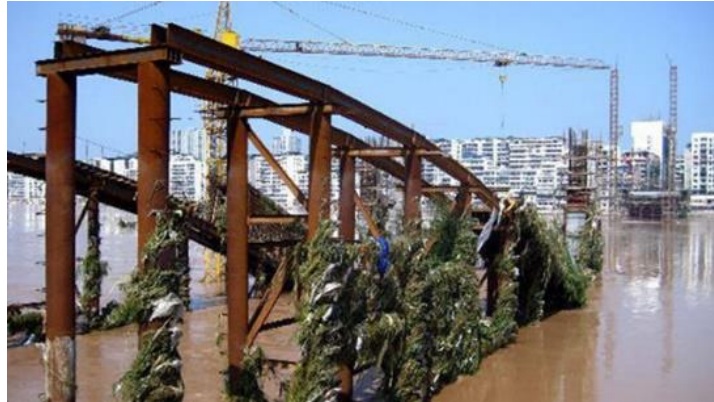
The Second Qujiang Bridge was an arch bridge, located in Dazhou City, Sichuan Province. It was 573 meters long and 15.5 meters wide. The construction began in 2008 and had expected to be completed in 2011. But in July 2010, after two-thirds of the total construction were completed, the project was destroyed by floods, as shown in Figure 2 (Xinhuashe, 2010). The bridge was under construction, so it was an unintegrated structural system. The instability of the bridge and the erosion

caused by the over expectation flood led to the destruction of the bridge. Pearson—III theoretic frequency curves are widely used to calculate flood rate in China. The design flood rate prediction is based on historical measurements. More historical measurements can improve prediction precision.

Figure 2. Collapse of Second Qujiang Bridge.

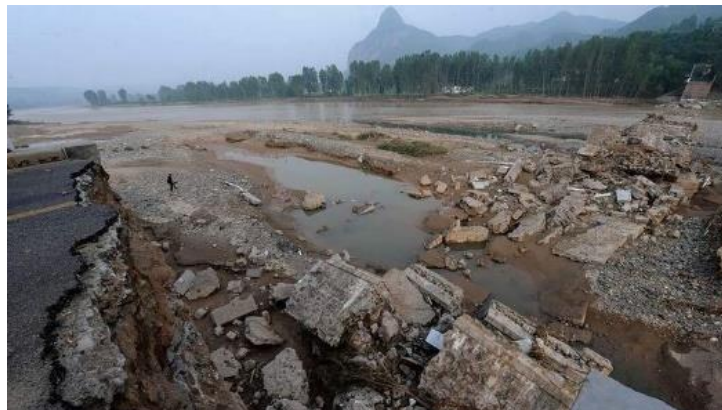
On July 24, 2010, Tangying Bridge in Luoyang City, Henan Province collapsed due to rainstorm, resulting in 53 deaths and 13 missing, as shown in Figure 3 (Zhaoting, 2010) .

Tangying Bridge was a continuous beam bridge with 233.7 meters long and 8 meters wide. The bridge, built in the 1980s, was a 5-span continuous arch bridge with a net span of 40 meters. It was made of stone and mortar without any reinforcement. This type of bridge structure is sensitive to foundation settlement. Any skewback foundation settlement will produce enormous secondary internal force. The flood scoured a skewback of the bridge and caused foundation settlement. Then the bridge collapsed under the action of a huge secondary internal force.

Figure 3. Collapse of Tangying Bridge.

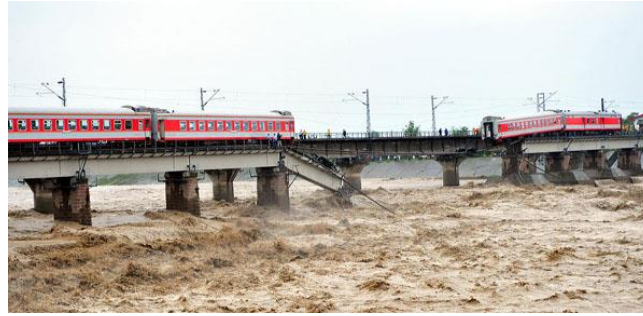
On August 19, 2010, Shiting Bridge of Baocheng railway was destroyed by flood, resulting in two sections of K165 train falling into the river, as shown in Figure 4 (Mengqi, 2010). Fortunately, there were no casualties.

Figure 4. Failure of Shiting River Bridge.

This bridge was constructed in the 1950s. It was a continuous beam with a net span of 16m. The piers were made of stone and the piles were made of wood. The pile cover was only 5 meters deep. Due to the weak discharge capacity of small span bridges, shallow foundations are particularly prone to erosion. Then two piers of the bridge were inclined due to the flood. When the train passed the bridge, two piers of the bridge collapsed.

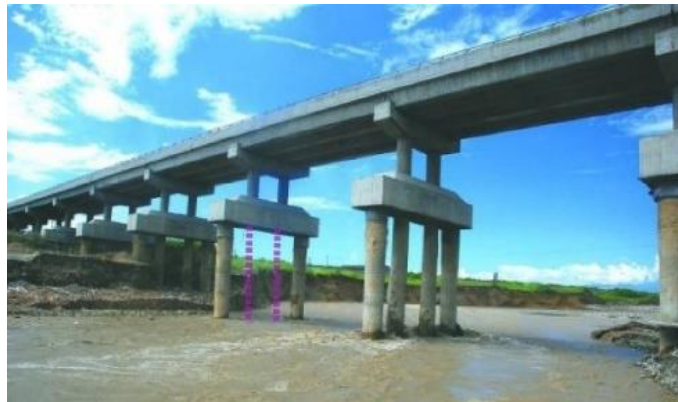
Mianzu Bridge, a continuous concrete beam, was located in Mianzu City across the Shiting River. It was 366.5 meters long and 10.75 meters wide. On August 18, 2012, two piles disappeared due to flood scour, as shown in Figure 5 (Guang, 2012). The dashed lines represent the disappeared piles in Figure 5.

Figure 5. Failure of Mianzu Bridge.

The 2008 Wenchuan earthquake caused a large number of gravel and finger stones to fall into the Shiting River, which resulted in narrow water way increasing the flow velocity downstream of blocked part of the river. This enhanced the scouring effect. In addition, the excessive exploitation of river sediment aggravated the decline of river stage. Therefore, the piles were washed away by the flood.

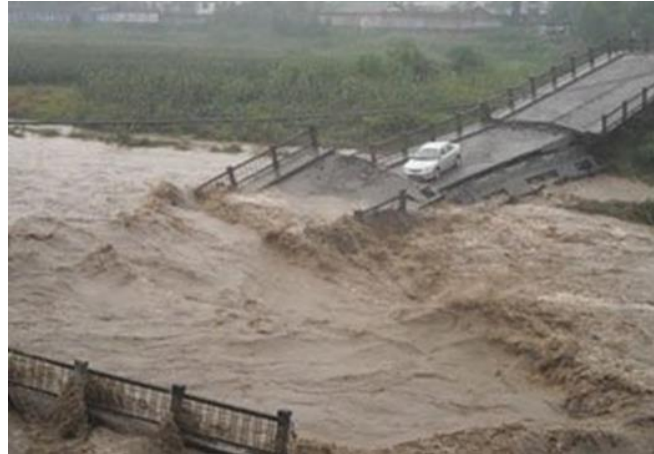
Huaiyuan Bridge was a multi-span simply supported beam bridge with a total length of 135 meters. On August 19, 2010, the bridge collapsed due to flood, as shown in Figure 6 (Ming kang, 2010). More than 60 meters of the bridge fell into the river. Two people died.

Figure 6. Collapse of Chongzhou Huaiyuan Bridge.

The bridge was built in the 1960s and was identified as an unsafe bridge with limited bearing capacity in 2008. After the 2008 Wenchuan earthquake, the river became narrow due to the deposition of finger stones. As a result, the flow velocity was accelerated and the scour was intensified. This undermined the bridge foundation. Then the bridge was destroyed by the flood.
