Research Article

Recent hydraulic bridge failures in China: review and discussion

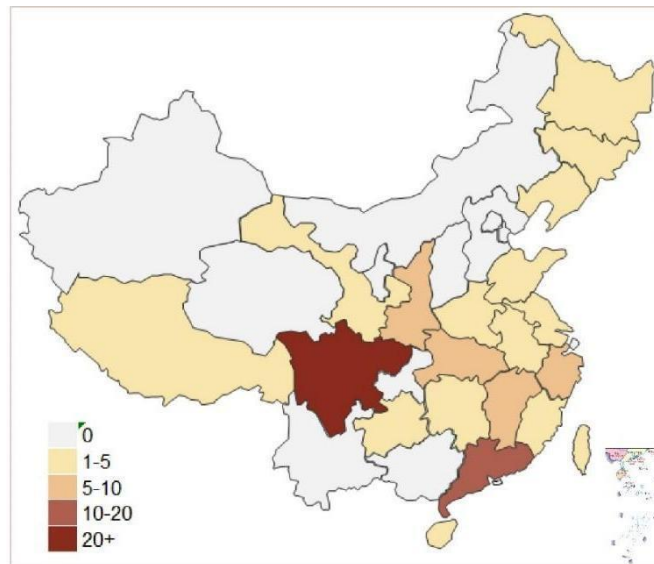
Figure 7. Distribution of damaged bridges across the country.

Sichuan Province has the highest number of hydraulic bridge failure, which is related to the impact of the Wenchuan earthquake. The 2008 Wenchuan earthquake led to a large number of sand and finger stones falling into the river, which resulted in narrow water way increasing the flow velocity downstream of blocked part of the river. Furthermore, the breached part of blocked water way caused rapid increase in velocity of sediment laden flow which had sufficient drag force and bed shear stress to further erode the bed than normal scour. (Ko, Chiou, Tsai, & Chen, 2014). In addition, some bridges have been damaged in varying degrees in the earthquake.

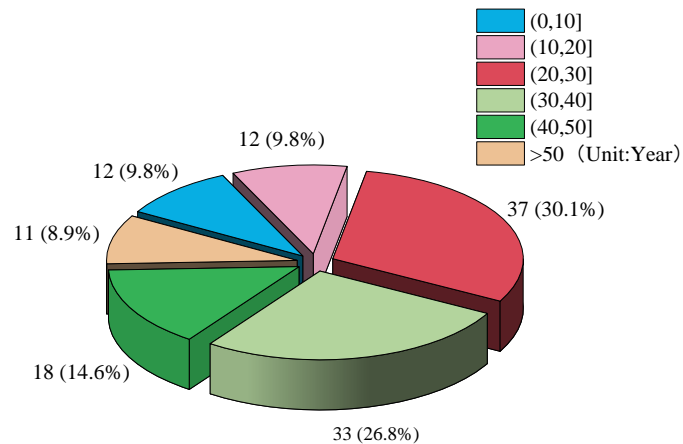
Figure 8. Age distribution of failed bridges.

The service life distribution of 123 bridges investigated is shown in Figure 8. The average service life of these bridges is 28.9 years. Guigou Bridge in Henan Province survived only one day because of the flood. However, the life of Dongmen Bridge in Guangdong Province is 82 years, and that of Qingdao Trestle Bridge in Shandong Province is 121 years. The life of most bridges is less than 35 years and cannot reach the service life.

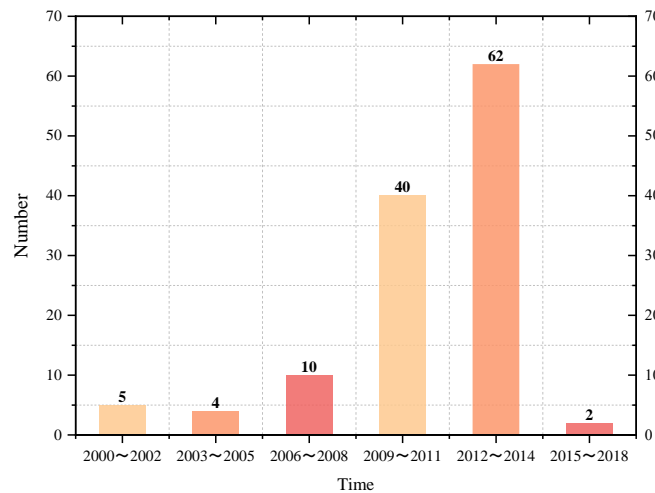
Figure 9. Time distribution of failed bridges.

The time of the hydraulic bridge failure is summarized, as shown in Figure 9. It mainly occurred between 2009 and 2014. During this period, the most hydraulic bridge failures happened in Sichuan Province, which was related to the impact of the Wenchuan earthquake. Some bridges were damaged in the Wenchuan earthquake and did not find or repair in time.

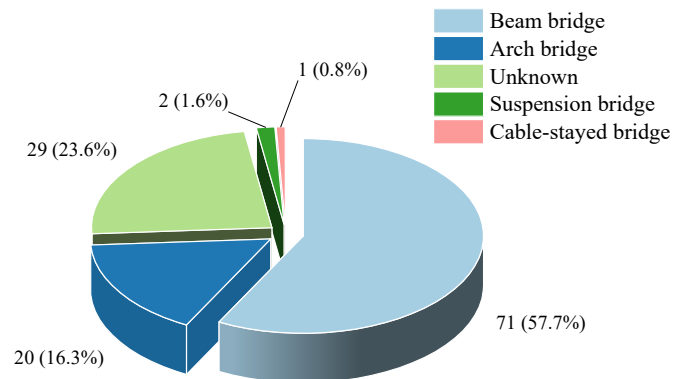
Figure 10. Bridge type distribution of failed bridges.

There are 71 beam bridges, 20 arch bridges, 2 suspension bridges and 1 cable-stayed bridge among the investigated bridges. The type of the other 29 bridges is unknown, as shown in Figure 10.

From 2000 to 2018, beam bridges accounted for the biggest share of hydraulic bridge failure. Suspension bridge and cable-stayed bridge take up a small proportion. Beam bridges have more piers and are prone to water scouring, leading to collapse. Arch bridges are generally built in mountainous areas. They are prone to collapse during floods or mudslides. In suspension bridges and cable-stayed bridges, cable is the main load-bearing structure, they are larger than the beam bridge span, suitable for building in the water depth, not easy to be destroyed by water.
