# Construction features of the historical architecture in the sea port city of Valparaiso: architect E.O.F. Harrington's brick masonry buildings

## Características constructivas de la arquitectura histórica en la ciudad portuaria de Valparaíso: Edificios de albañilería de ladrillo del arquitecto E.O.F. Harrington

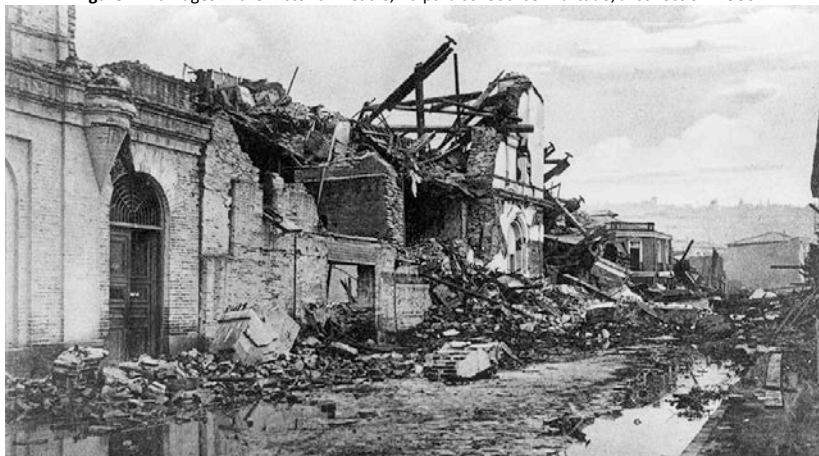
Figure 1. Damages in the Victoria Theatre, Valparaíso. Source: Hurtado, J. collection. 1906.

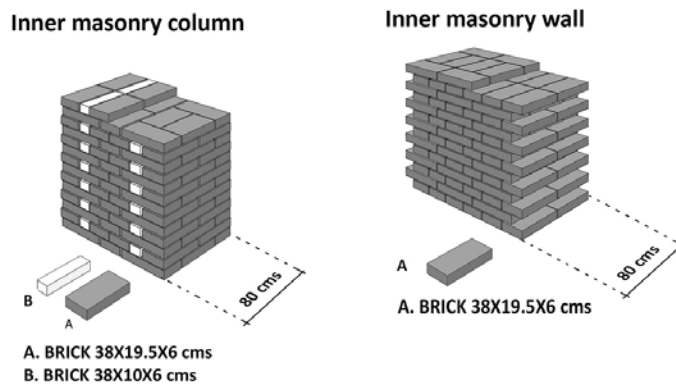
Figure 6. Bonding details. Source: Authors, 2014.

The dimension of the brick unit mainly used is 38 x 19.5 x 6 cm, and sometimes the link header is 38 x 10 x 6 cm; all are joined by lime mortar. Typologies binding were mostly found in stretcher bond and the head; however, a variation between the walls and columns in the basement (Figure 6) was also found.

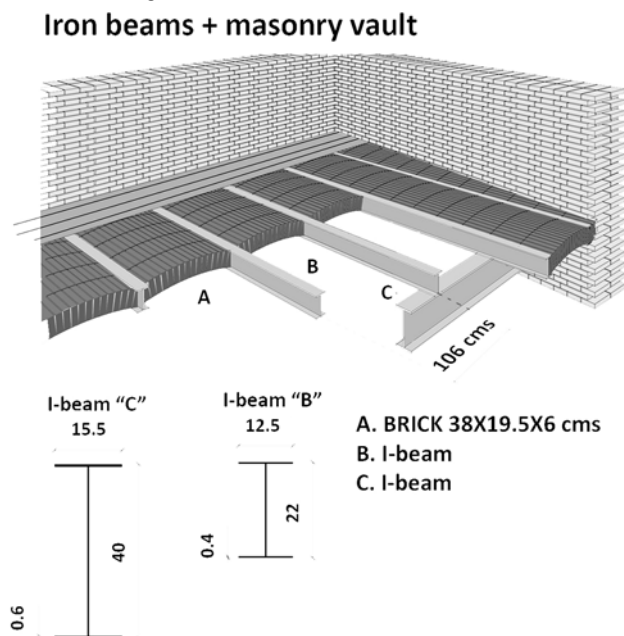
Figure 7. Mezzanine detail. Source: Authors, 2014.

In the building, two structures are identified as being used for mezzanines: iron beams with brick vaults, and wooden beams. The first is used in the basement and on the first floor. This is configured in iron beams of double T-shaped 40 x 15.5 cm beams at 6 mm thick, and they are arranged every 3 or 3.5 m with the axis above the columns of iron or brick masonry (depending on level in the longitudinal direction of the building). On top of these structural beams, iron double T-shaped beams are placed in the shortest dimension of 22 x 12.5 cm and 4 mm thick, and they are arranged 100 cm from each other in the axis average transverse direction of the building. Brick vaults were placed in the space 100 cm between the joists. The beams were embedded in the walls and pillars of brick masonry, leaving a space at the junction for mounting the beam. The resulting gaps are filled again with brick. This slab was covered with ceramic or wood in order to obtain the finished floor (Figure 7).

In order to build the openings, both for facades and as interior brick walls, different types of brick arches were built. Brick masonry in general involves two bundles of regular bricks—forming the width of the wall—and bricks bound in mid-header to finish and give continuity to the walls when there is an opening. The flattened arc, the arc midpoint, and the arch and three types of bows found for construction openings. The former is used in openings, in the basement, and in the first and second floors (it was also found in the upper joint of the brick columns placed in the basement as a beam in order to distribute the weight). The arc is the midpoint and is used on the facades of the first, second, and third floors. Finally, the lowered arches are used to deliver the weight from the first floor to the pillar in the basement, which were arranged approximately every 3.3 m wheelbase, and also placed in some of the inner walls (Figure 7).
